SAFETY STUDY

HAM-CR 464-0.00/1.04

Ludlow Avenue Corridor Study - Central Parkway (US 127) to Whitfield Avenue

FINAL REPORT

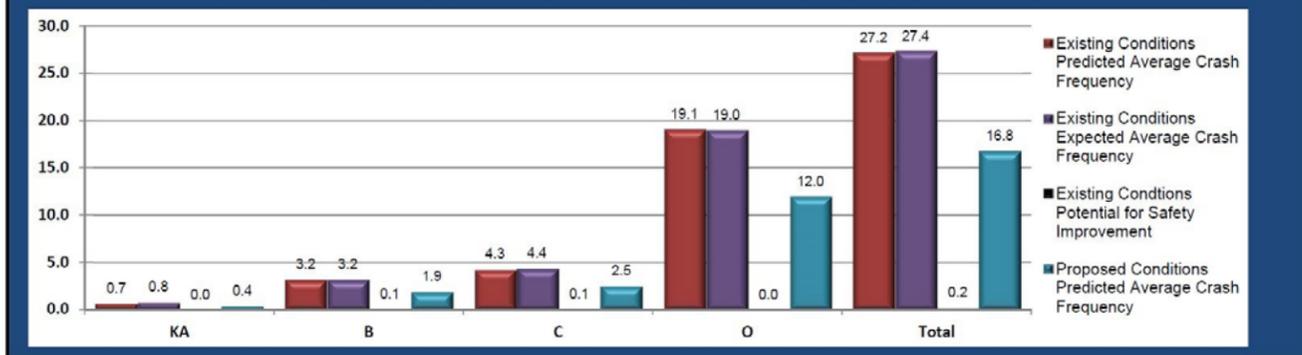
Summary of Anticipated Safety Performance of the Project (average crashes/year)

The proposed countermeasures were incorporated in the ECAT analysis and applied to the specific project elements as appropriate. The results indicate that the Proposed Conditions Predicted Average Crash Frequency is lower than the Existing Conditions Expected Average Crash Frequency and the Existing Conditions Predicted Average Crash Frequency. The difference between Existing Conditions Expected Crash Frequency (27.4376 crashes/year) and the Proposed Conditions Predicted Crash Frequency (16.8320 crashes/year) is more than 10 crashes per year, which is a 38.7% improvement over Existing Conditions. The Project Safety Performance Report is located in Appendix E.

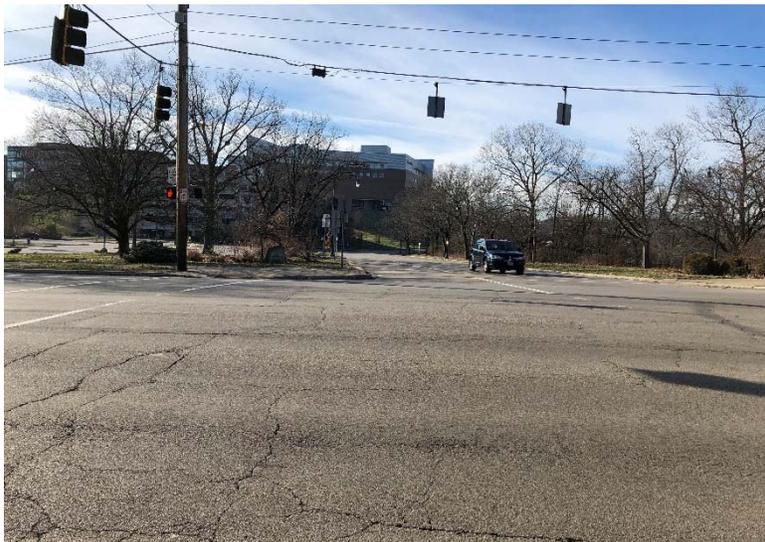
Figure 1 - Central Pkwy approach to Ludlow Ave looking SW

The major intersection in the study corridor is with Central Parkway (US 127), a Primary Arterial. This signalized T-intersection has two through-lanes on each approach, right-turn slip ramps (by-pass lanes) on the southbound and eastbound approaches and a dedicated left-turn lane on the northbound approach. US 127 is designated on the Central Parkway approach and the north leg of Ludlow Avenue. CR 464 begins at this intersection on the south leg of Ludlow Avenue.

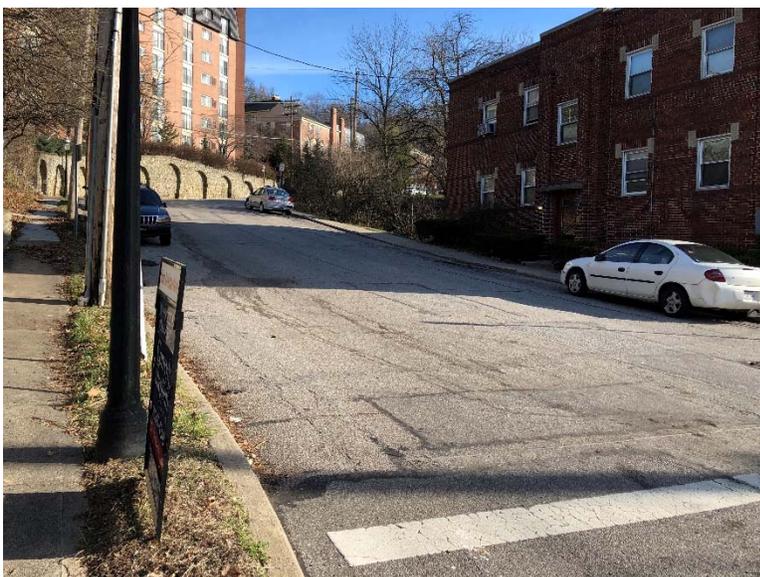
Figure 2 - East leg of Rue De La Paix approach to Ludlow Ave

The signalized intersection of Rue De La Paix is located 0.1 mile southeast of the Central Avenue intersection. The east leg of Rue De La Paix is a dead-end local street that provides access to two large, multi-family housing buildings and terminates at the Clifton Place Independent Living Apartments. This approach has one lane in each direction. The west approach to the intersection provides access to three surface parking lots and one parking garage for Cincinnati State. This approach has two lanes in each direction, including an exclusive

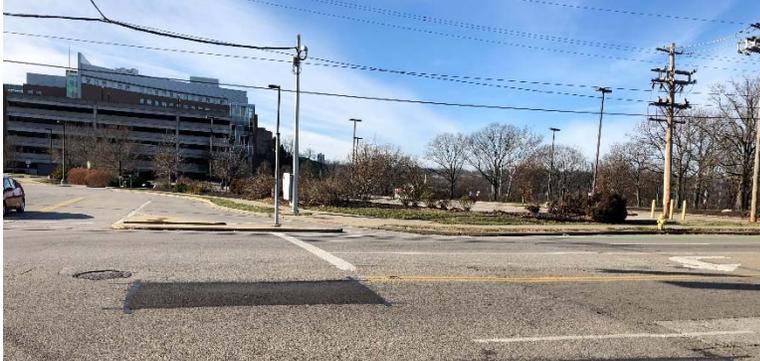
Figure 3 - Right-turn slip ramp from SEB Ludlow Ave to Rue De La Paix

left-turn lane onto Ludlow Avenue. The southbound approach of Ludlow Avenue has a free-flow right-turn slip ramp onto the west leg of Rue De La Paix and a dedicated left-turn lane onto the east approach of Rue De La Paix. The northbound approach of Ludlow Avenue has a dedicated left-turn lane on the west leg of Rue De La Paix.

The SEB right-turn slip ramp at Rue De La Paix is also proposed to be removed, for the same reasons. At this intersection, the outside through lane will become an exclusive right-turn lane. This allows for the transition into the Road Diet typical section. The total number of signal approach lanes on the SEB leg of the Rue De La Paix intersection will remain the same.

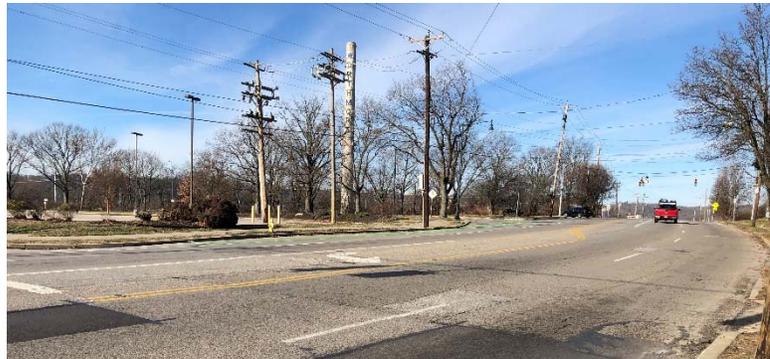
Figure 4 - Bike lane on SEB Ludlow Ave between Central Pkwy and Rue De La Paix

bike lane starts at the 5-point intersection, travels across the viaduct and terminates at a driveway for Cincinnati State located south of Rue De La Paix. At this point, the bike lane transitions to a shared lane with vehicular traffic, and a “sharrow” marks the transition point. The bike lane is identified with green pavement markings at merge/diverge areas for the right-turn slip ramps at Central Parkway and Rue De La Paix.

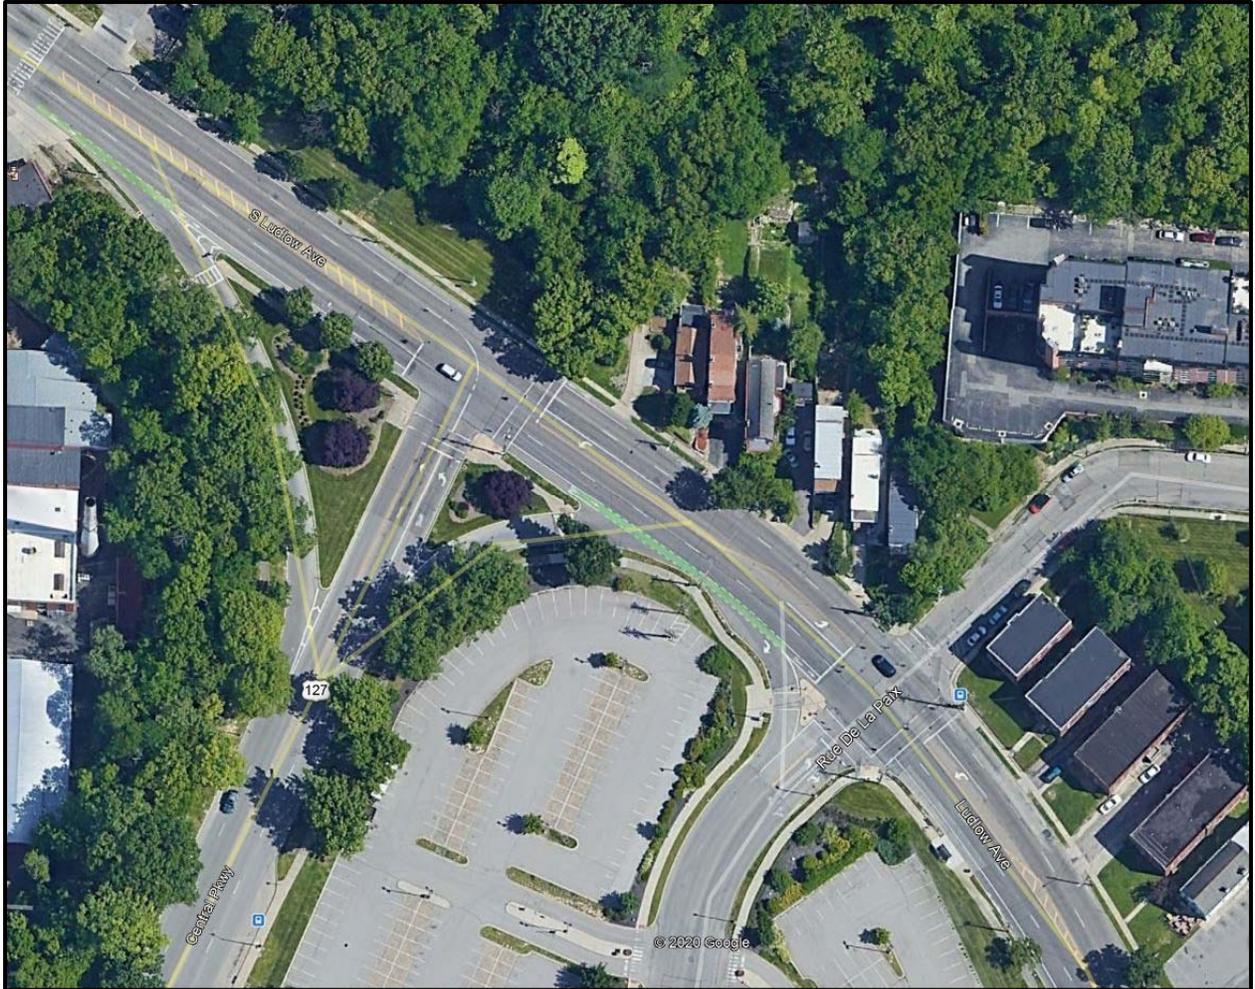
Figure 6- Central Parkway and Rue De La Paix intersections with Ludlow Avenue

The primary modification at the Central Parkway intersection is removing the long-radius right-turn slip ramps (bypass lanes) for the SEB movement and the NB movement. The ramps rerouted right-turn traffic from the signalized intersection, improving traffic flow at what was formerly an extremely high volume location. With the changes in local traffic patterns that accompanied revisions to the I-75 access points, these slip ramps are no longer necessary to provide adequate Level of Service, as indicated by the Existing Conditions analysis. Additionally, these ramps encourage excessive speeds, create additional conflict points in the intersection area, and create extra pedestrian exposure to vehicles. Removing these ramps will calm vehicular traffic and improve pedestrian safety. This particular countermeasure is not reflected in the ECAT analysis because there are no CMFs available for this particular improvement. The SEB right-turn movement on Ludlow Avenue will be incorporated into the outside SEB through lane. The NB right-turn movement on Central Parkway will be incorporated into the outside left-turn lane. The total number of signal approach lanes will remain the same on the primary roadway alignments; the only modification is removing the slip ramps that currently operate outside the signalized movements.

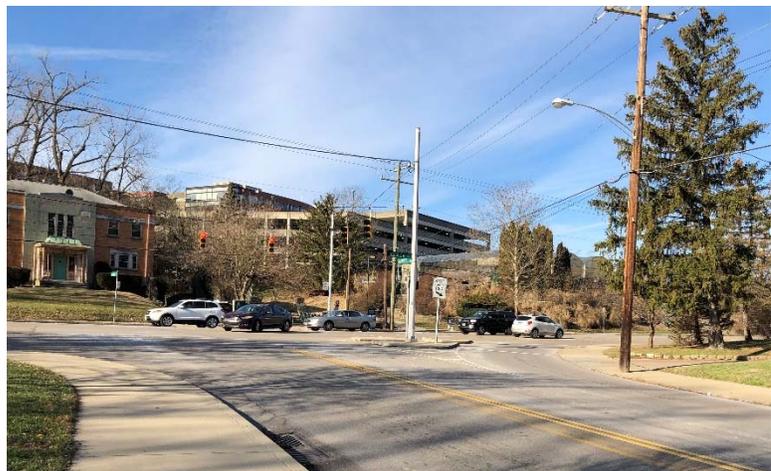
Figure 7 - Right-turn slip ramp on Lafayette Ave at Ludlow Ave uses a channelized concrete median to separate the right-turn movements from the left-turn movements. The turning radii on Lafayette Avenue are very long, which creates a minimum 56-foot crossing distance to reach the channelizing island serving as a pedestrian refuge. The only pedestrian

crossing on Ludlow Avenue uses the channelizing island as its east-side terminus, and pedestrians must either cross the slip ramp to continue north or the very wide throat of Lafayette Avenue to continue south.

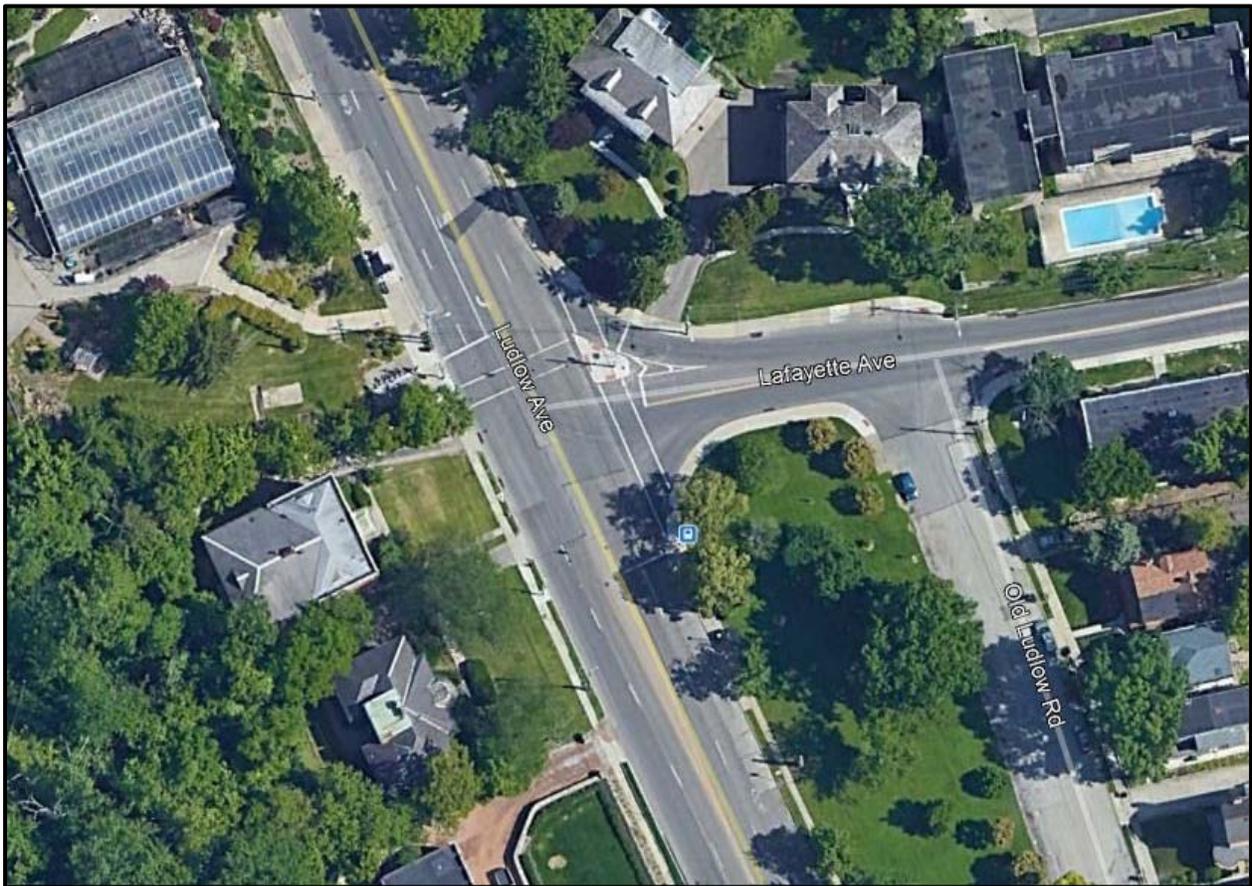
Figure 9 - Lafayette Avenue & Ludlow Avenue Intersection

Figure 9 is an aerial photo of the Lafayette Avenue & Ludlow Avenue intersection.

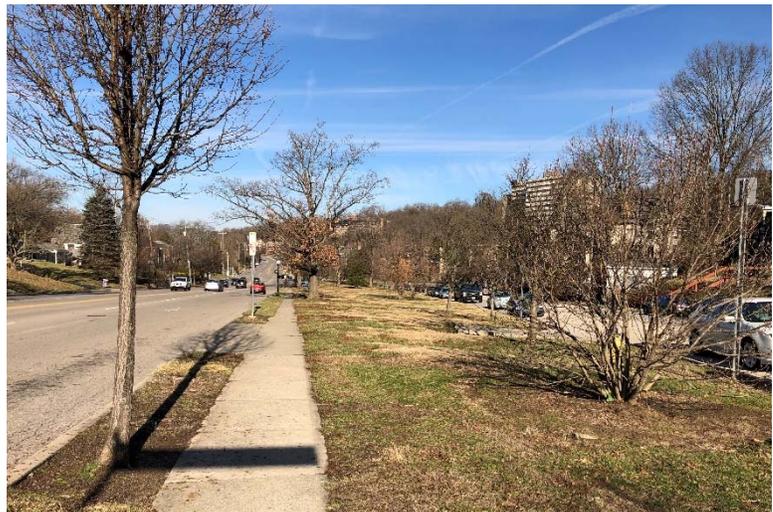
Figure 10 - Ludlow Avenue looking NW at transit stop across from Clifton Hills Ave

Ludlow Avenue serves primarily single-family homes between Lafayette Avenue and Cornell Place. While there are 9 transit bus stops in this 0.7-mile section of Ludlow Avenue, there are no marked crosswalks on Ludlow Avenue to support pedestrian access to these stops. A typical situation is represented by the area around Clifton Hills Avenue, which does generate pedestrian traffic crossing Ludlow Avenue at the beginning of DePaul Cristo Rey High School’s day (**Figures 10-13**).

2. **Install Rectangular Rapid Flashing Beacon at midblock crossing.** The City of Cincinnati is specifically concerned about increased pedestrian crossings that are related to the NWB transit bus stop located northwest of the Clifton Hill Avenue T-intersection. Since this crossing is located where traffic on Ludlow Avenue is otherwise not controlled, an RRFB is recommended to provide greater visibility when pedestrians are in the crosswalk.

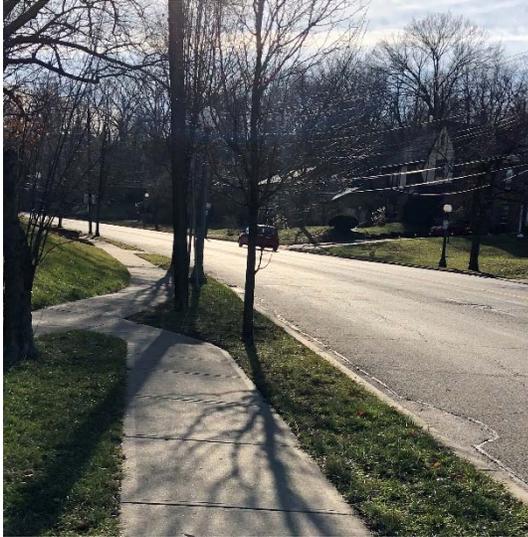
Figure 11 - Ludlow Ave looking SE at Clifton Hills Ave

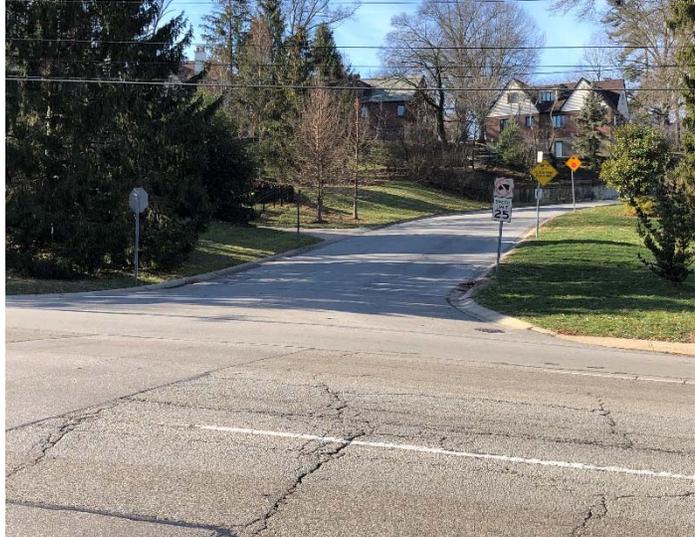
Figure 12 - Clifton Hills Ave approach to Ludlow Ave

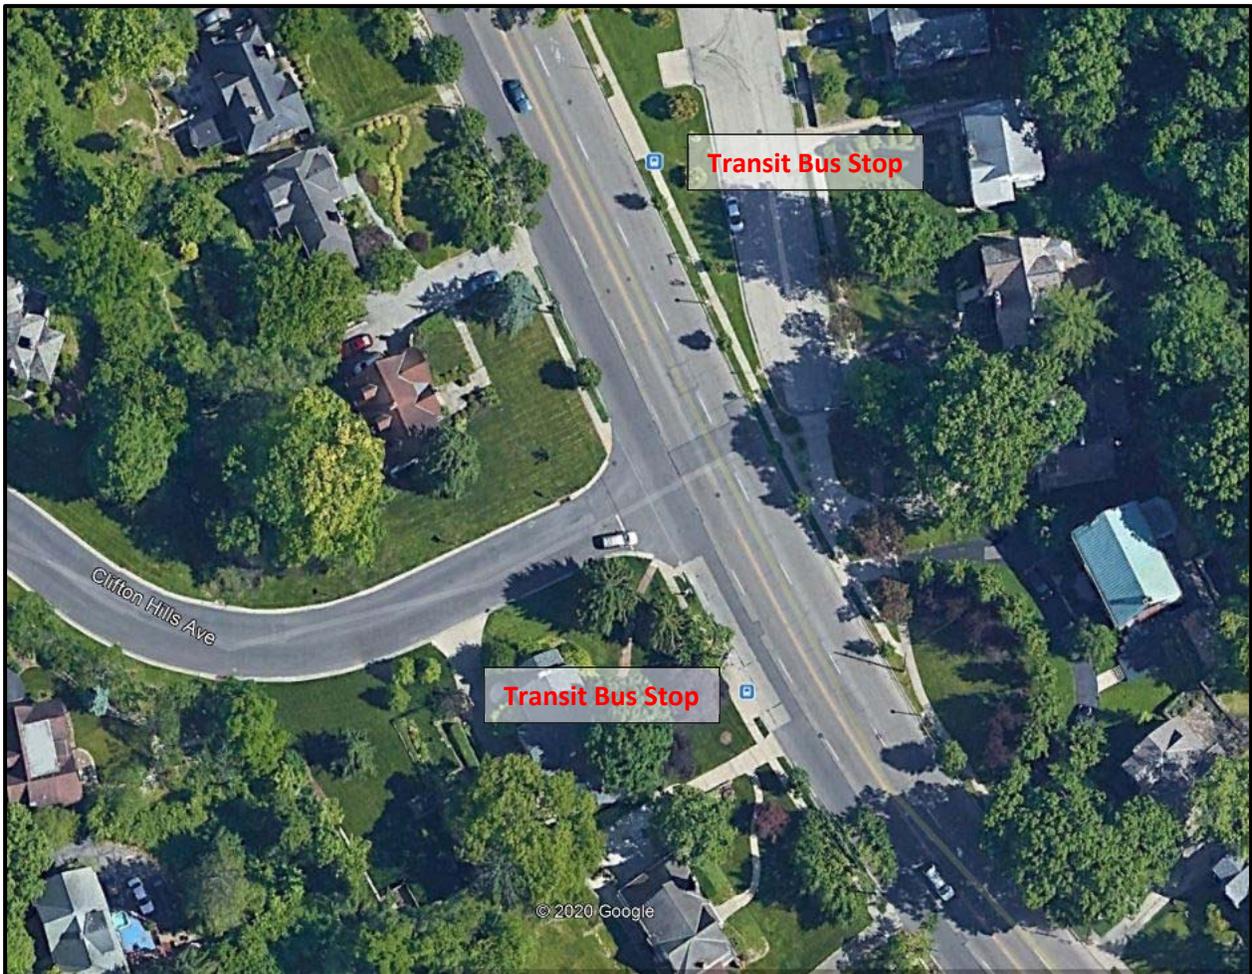
Figure 13 - Clifton Hills Avenue and Ludlow Avenue intersection area

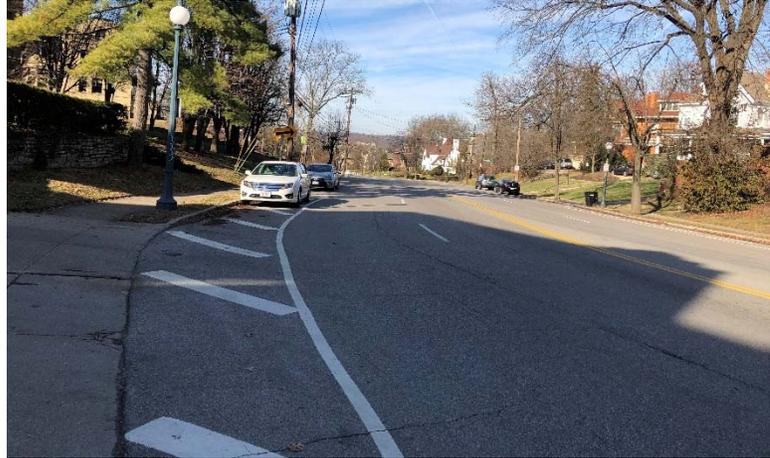
Figure 14 - Pavement markings for end of on-street parking

At Cornell Place, the roadway characteristics and the surrounding land uses transition to represent the neighborhood's central business district. Housing density increases, there are several multi-family residential buildings, and the study area ends near the edge of a commercial district. On-street parking ends at a bend in the roadway alignment where Ludlow Avenue takes on an east/west orientation.

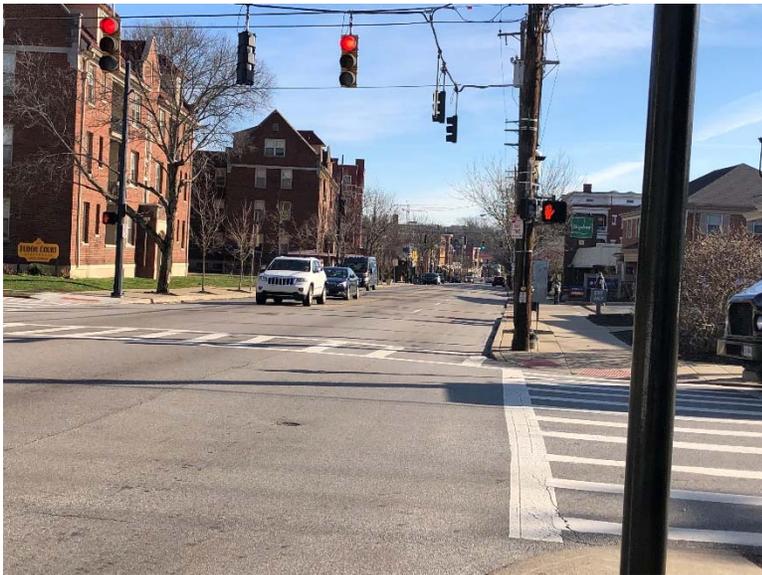
Figure 15 - Study end point at Whitfield Avenue, looking east

The study area terminates at the signalized, offset Whitfield Avenue intersection where Ludlow Avenue has two lanes in each direction and Whitfield Avenue has one lane in each direction. There are no turn lanes present. Pedestrian crossings are provided on both Whitfield Avenue approaches, and a single crossing on Ludlow Avenue is located between the two Whitfield Avenue approaches. **Figure 16** is an aerial photograph of 0.1-mile section of the corridor between Sherlock Avenue and Whitfield Avenue, where the transition between the wider pavement section and the 40-foot pavement section occurs.

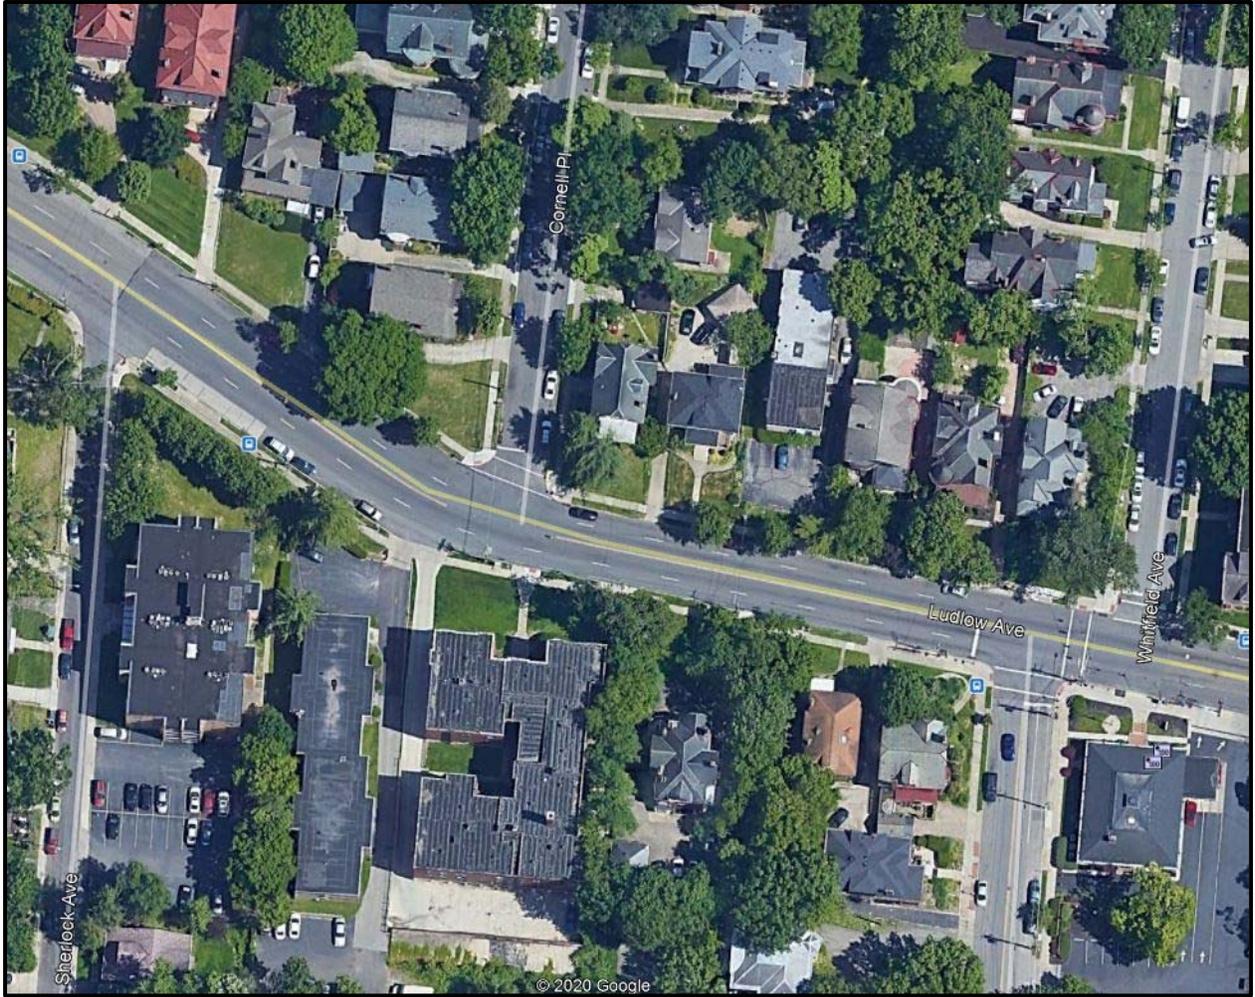
Figure 16 - Sherlock Avenue to Whitfield Avenue corridor

has two lanes in each direction and Whitfield Avenue has one lane in each direction. There are no turn lanes present. Pedestrian crossings are provided on both Whitfield Avenue approaches, and a single crossing on Ludlow Avenue is located between the two Whitfield Avenue approaches. **Figure 16** is an aerial photograph of 0.1-mile section of the corridor between Sherlock Avenue and Whitfield Avenue, where the transition between the wider pavement section and the 40-foot pavement section occurs.

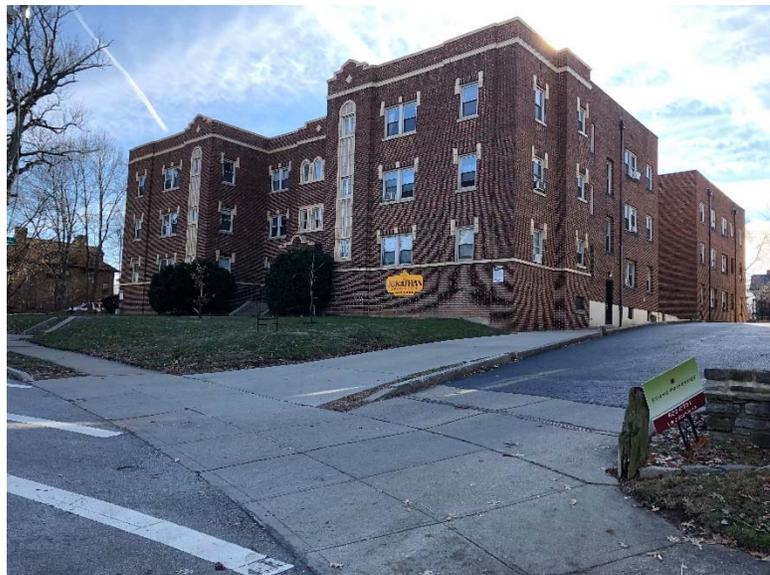
Figure 3 - Building opposite Cornell PI that was struck

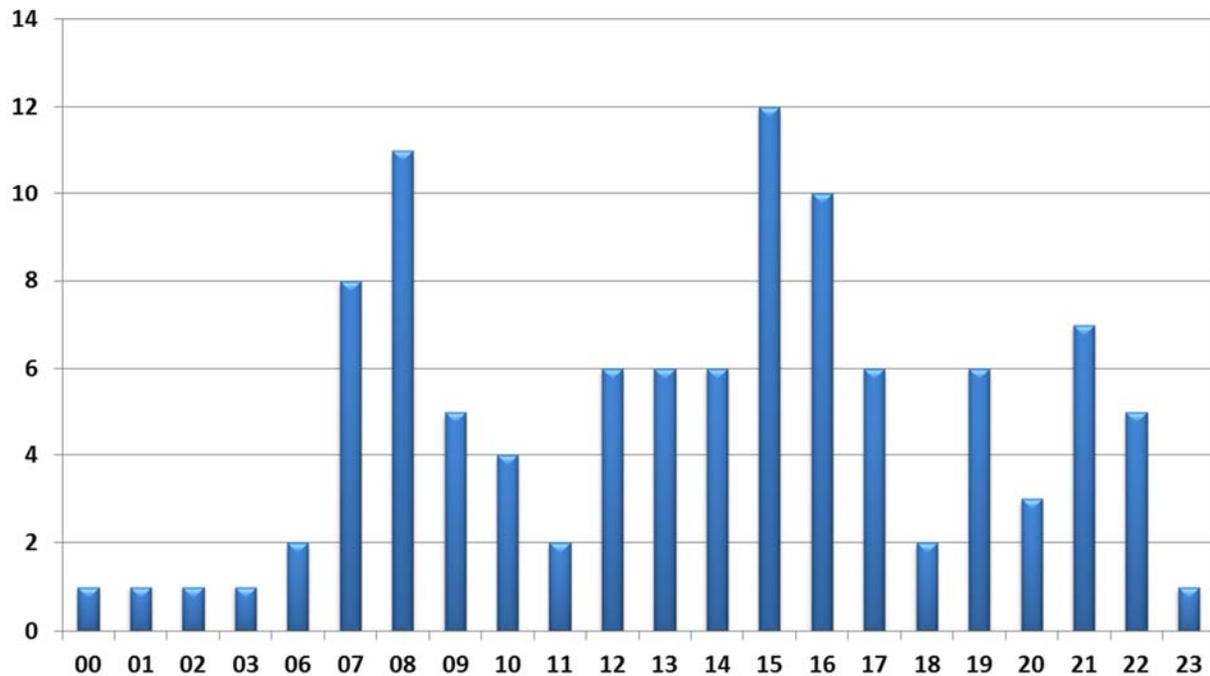
Frequency of Crashes by Hour

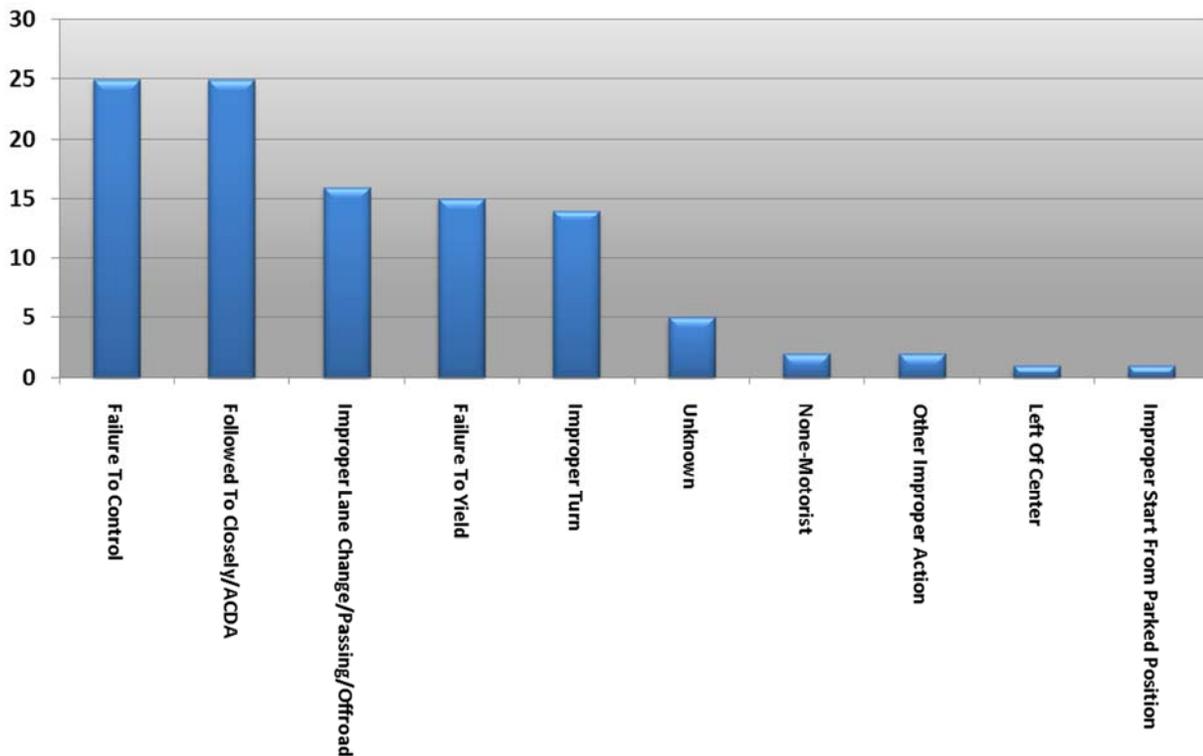
Frequency of Crashes by Contributing Factor 1
